North Green Play Park

ROSPA Report and Scheduled inspection findings

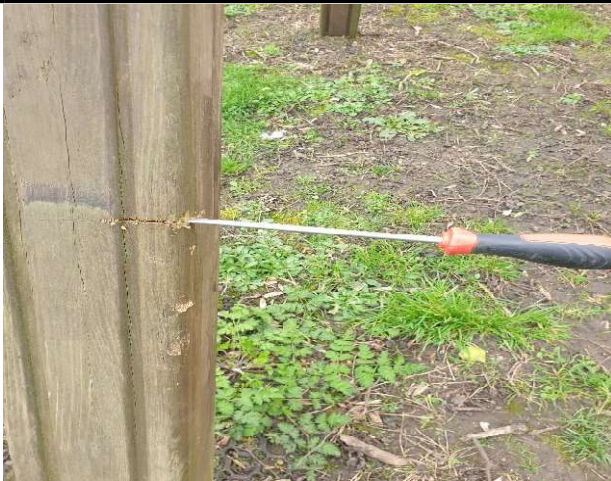
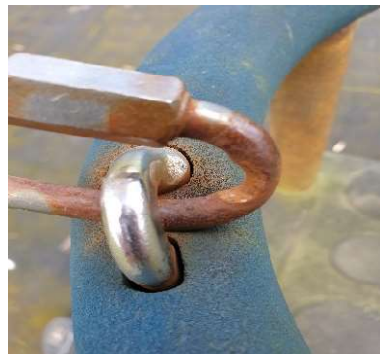
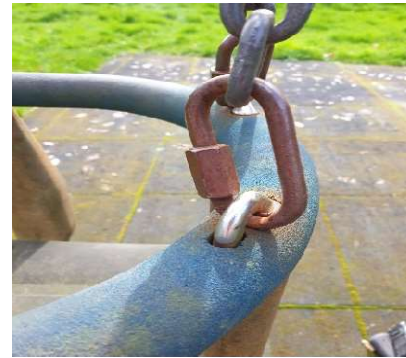
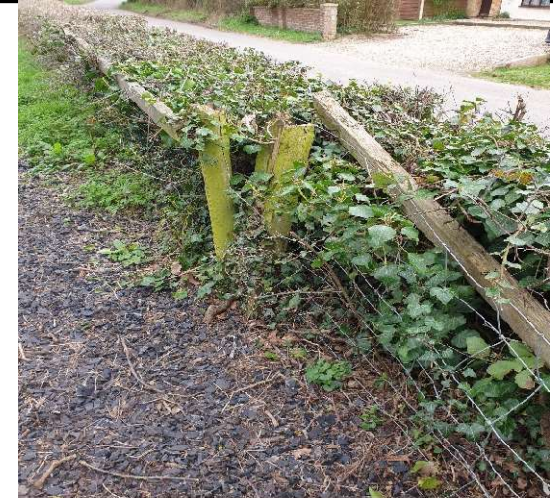
Equipment & Defects Identified	Recommended Actions	Notes	Actions Planned / Completed	Date
Wood entrance Gate. Spring closer loose	Re-fit Spring closer		Re-attached	Mar-24
Bench Seating, End caps missing	Fit End Caps		7 MISSING, Order placed for replacement £9.29	Mar-24
Seating, Gaps between slats greater than 30mm and are known to cause entrapments	None Recommended	Item as purchased		No Action
8 Seater Picnic Table		OK	Security chain required	
Gate Double Metal		OK		
Boundary, Fencing, Vegetation - Grass cutting	Repair Fence, Trim Vegetation	See Picture 4d	Replace fence post at gate and behind MPLU	
Bin Rubbish		OK		
Swing Mixed, Chain covers prevent inspection	Remove chain covers		Will be removed prior to next inspection	Jun-24
Swing Mixed, Saw cut to support beam	Infill and re-stain	See picture 4a		
Carousel,		OK		
Multi Play Log Unit With Slide, EN 1176-1:2017 Equipment not compliant with the requirements of the relevant standards.		Item as purchased	The equipment was purchased some years ago it may be a reasonable assumption it met spec at that time. Ensure play park equipment meets latest soec when next upgraded	N/A

MPLU, Head entrapment.	None recommended	Item as purchased	Old pre-EN unit with entrapments. Monitor	N/A
Horizontal guard rails without vertical or solid infill	None Recommended	Item as purchased	Old pre-EN unit with entrapments. Monitor	N/A
MPLU, Strimmer Damage	Prevent further damage. Remove grass/weeds base of supports	Prevent further damage. Remove grass/weeds base of	Glyphosate Herbicide used around all supports, x 2 in the growing season	Apr-24
MPLU, Hedge encroachment	Cut Back Hedge	Excite Contractors		2024
MPLU, Protruding Bolt	Monitor	Bolt Tight, Monitor		
Slide - Embankment, Gaps have opened up between tiles causing trip hazard.	Re-glue and fill gaps and joints as necessary	Work group task		2024
Swings Toddler, 1 Bay 2 swings. Matting Gaps	Re-glue and fill gaps and joints as necessary	Work group task		2024
Swings Toddler, 1 Bay 2 swings. Lower couplings worn	Replace all lower couplings	See Picture 4b & 4c

Rocker - Daisey, The supports are loose in the ground	Spring base loose in the ground, allowing the unit to lean to one side. Re-set.	Source Info on Ground Fixing	Monitor for deteriorate, Checked March 24, OK	Mar-24
Multiplay - With Tunnel & Bridge,	EN 1176-1:2017 The item is not compliant with the requirements of the relevant standards. The surfacing meets with the requirements of the relevant standards.	Item as purchased	The equipment was purchased some years ago it may be a reasonable assumption it met spec at that time. Ensure play park equipment meets latest spec when next upgraded	N/A
Multiplay with Tunnel & Bridge. The opening in the barrier on this easily accessible steep play element is wider than 500 mm.	No reasonably practicable action is identified.	Item as purchased	As Above	
Rocker - Seesaw, EN 1176-1:2017, EN 1176-6:2017 The item and its surfacing (where applicable) meet with the requirements of the relevant standards.	Gaps have opened up between tiles causing trip hazard	Work Group Task. Refit the tiles.
